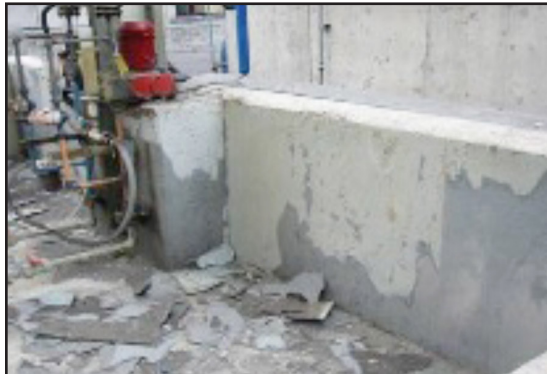
Coating destroyed in secondary containment bund after spills of aluminum sulfate.

Reinforcement content of previous coating allowed wicking of aggressive chemicals. Substrate attack caused failure.

Failed coating after spills

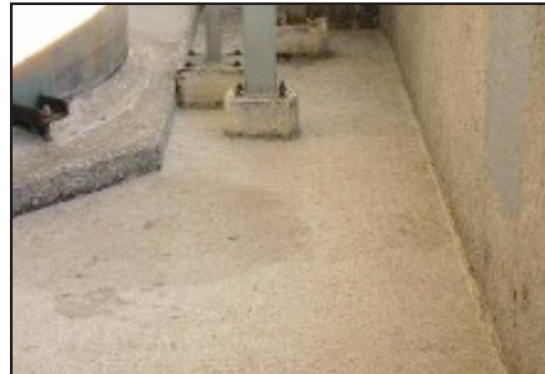
Cleaned and prepared surface

- HP water blast 600 bar (8500 psi)
- Decontaminate with IMS II

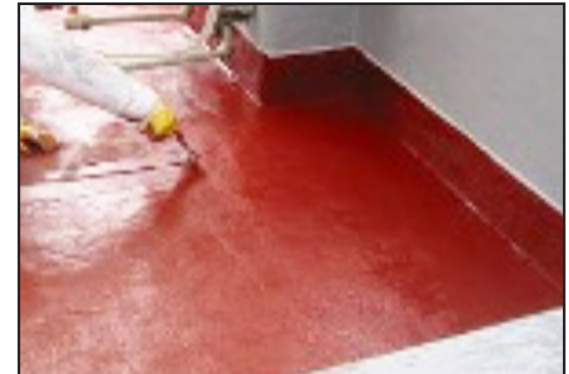
Applying ARC CS4 topcoat

1. Apply **ARC 797** to prime
2. Apply **ARC 988** to pitch to grade
3. Apply **ARC CS4** to seal floor
4. Apply **ARC CS2** to protect walls
